UNDERWATER BRIDGE INSPECTION REPORT

STRUCTURE NO. 7137

WATSON SAG CHANNEL

MINNESOTA DEPARTMENT OF TRANSPORTATION
UNDERWATER BRIDGE INSPECTION

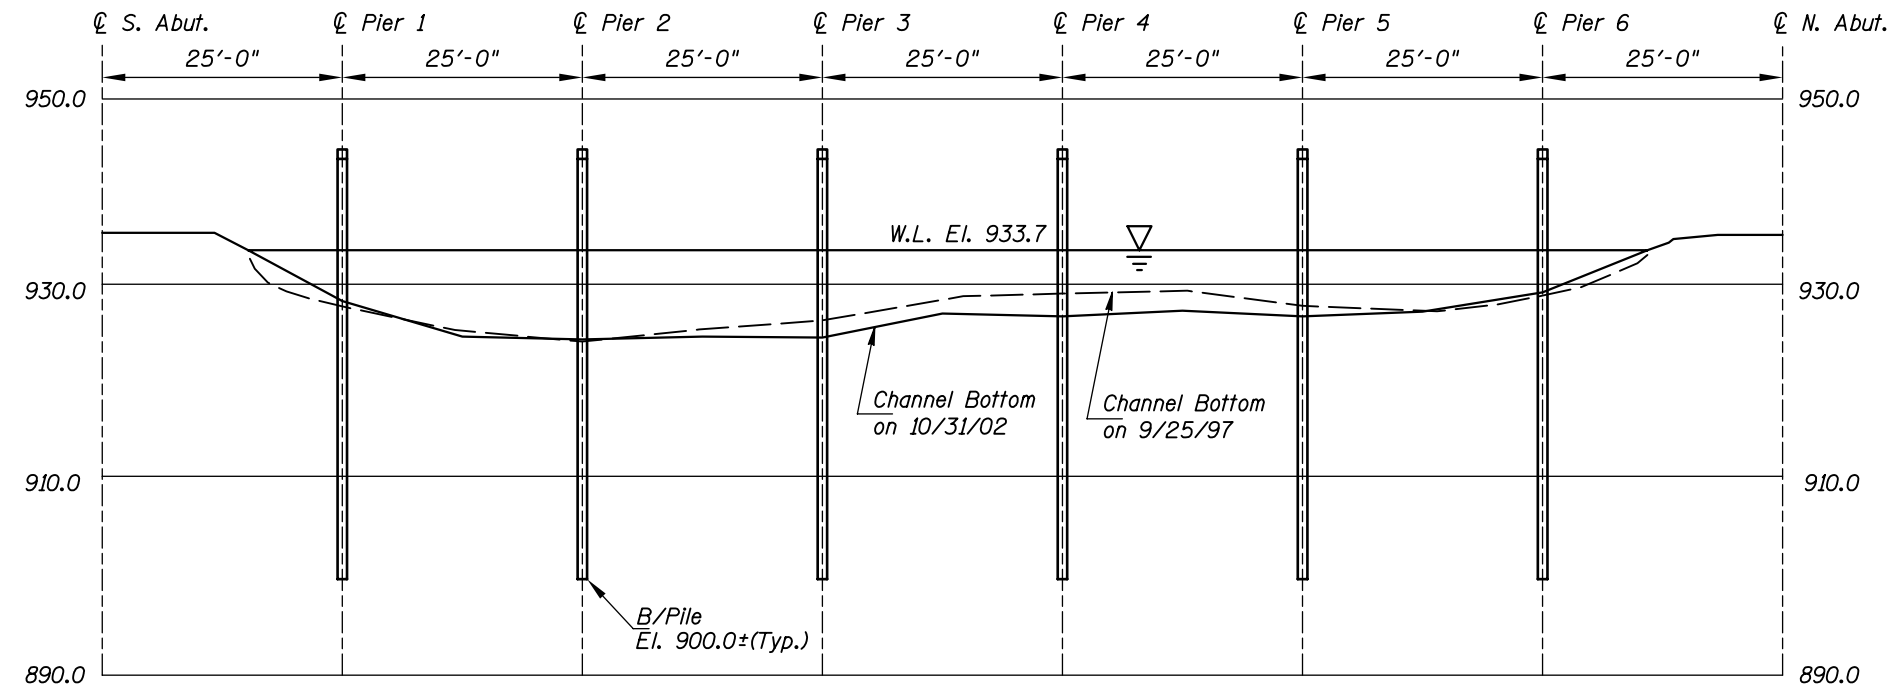
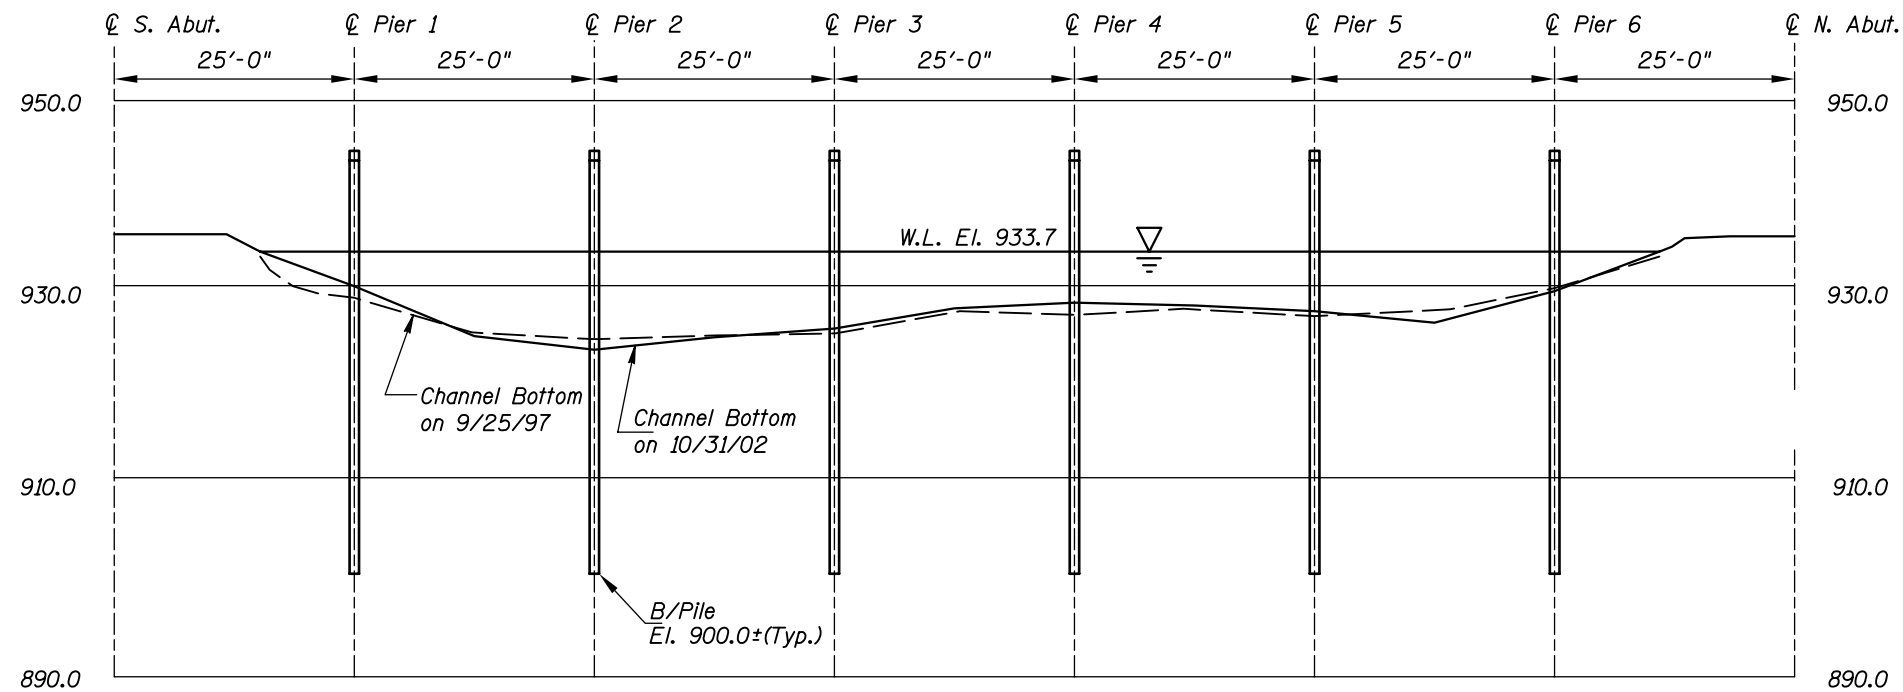
UPSTREAM FASCIA PROFILE

- 1 The channel bottom material consisted of sandy silt and scattered 6 inch diameter riprap with up to 3 inches of probe rod penetration.
- 2 Light corrosion was observed on the steel piles from 3 feet above the waterline to the channel bottom with random minor pitting having a maximum penetration of 1/16 inch.

- 3 Minor splitting and checking of the timber piles was observed from the pier cap to the channel bottom with a maximum width of 1/4 inch and a maximum penetration of 1 inch.

- 4 Diagonal timber bracing was split through the fastener.
- 5 Abrasion damage observed on the timber pile, from 1.0 foot above the waterline to 2.5 feet below the waterline, approximately 8 inches wide with a maximum penetration of 0.5 inch.

- 6 Delamination on outer shell of timber pile was observed around the waterline with maximum penetration of 1/2 inch.
- 7 Split in pile, from the top of the pile cap to 8 feet above the waterline with a maximum width of 1/2 inch and 1 inch of penetration.

- 8 Split in pile, from the pile cap to 2 feet above the waterline with a maximum width of 3/4 inch and 2 to 3 inches of penetration.
- 9 Diagonal bracing broken and no longer attached to pile.

- (A) Replace the split and/or broken diagonal timber cross bracing to restore the lateral stability of the structure.
- (B) Reinspect the submerged substructure units at the normal maximum recommended (NBIS) interval of five (5) years.
